## Comparison of Historic and Current Site Attributes Middleton Site

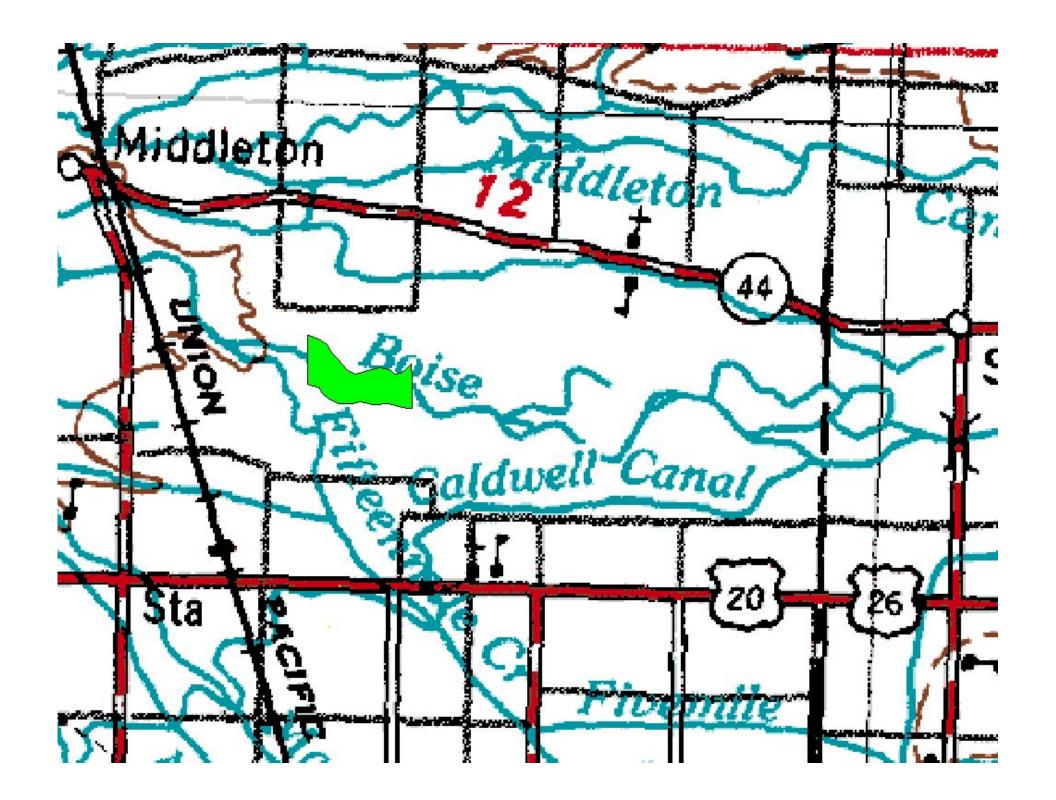
1867

2000

Bankfull Width

160m

87m

Parafluvial Surfaces Some Islands and Sand bars

Run, exposed islands

**Side Channels** and **Soughs**

Abundant development of sloughs

Sloughs filled or converted
To irrigation or drain ditches
